Manhole Inspection Summary

Manhole # S45GG_059MH

Insp Date: **3/13/08 1:39 PM**

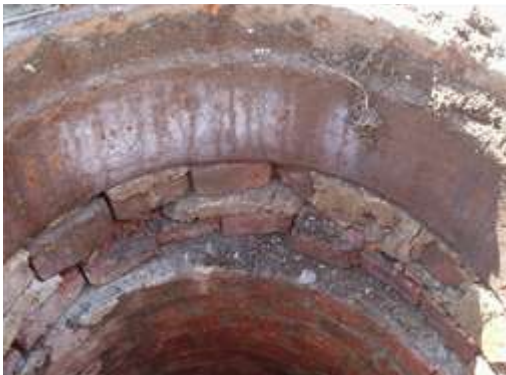
Defect 2

Condition: ☐ Sound ☐ Cracked ☐ Root Intrusion ☒ **Loose Brick** ☐ Deteriorated

Loose bricks

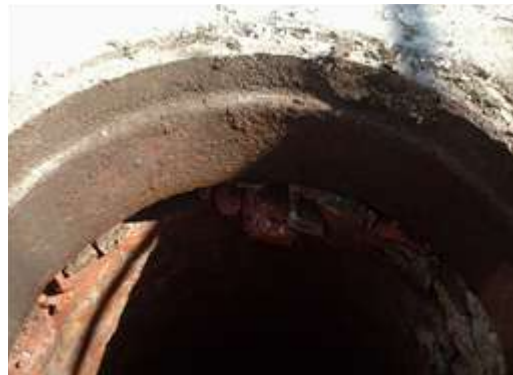
Defect 1

Frame Offset: **4** (in.) Condition: ☐ Sound ☐ Cracked ☒ **Leaks**

Adjustment joint

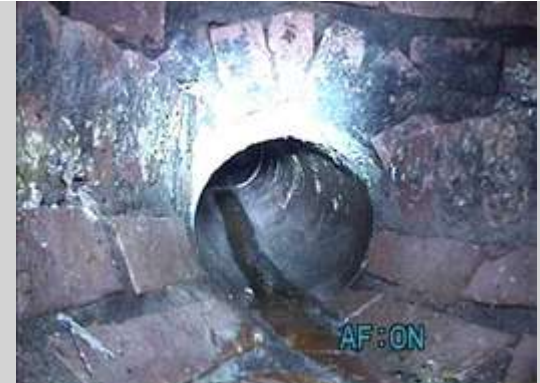
12 O'Clock Outflow

8 in. Circular Gravity Sewer
Pipe Out @ 12 O'Clock

Pipe Height: **8.4** (in.) Rod and Bar (Angled)
Pipe Material: **Clay** ☐ Pipe Lined
Invert Depth: **10.50** (ft.) Flow Characteristics: **Fast**
Deposits: ☒ None ☐ Mud ☐ Sludge ☐ Debris ☐ Grease
Silt Depth: (in.) Deposits Extent:
Infiltration: **None** Pipe Seal Cond: **Sound**

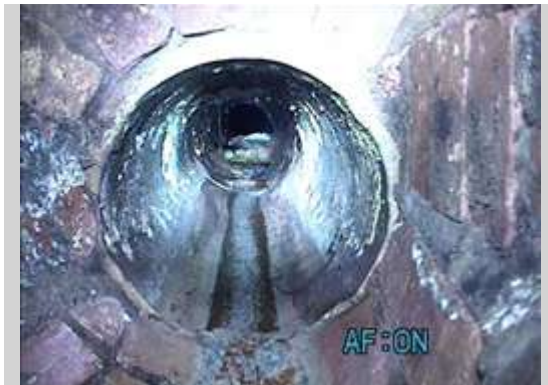
3 O'Clock Inflow

8 in. Circular Gravity Sewer
Pipe In @ 3 O'Clock

Pipe Height: **8.4** (in.) Rod and Bar (Angled)
Pipe Material: **Clay** ☐ Pipe Lined
Invert Depth: **10.00** (ft.) Flow Characteristics: **Fast**
Deposits: ☒ None ☐ Mud ☐ Sludge ☐ Debris ☐ Grease
Silt Depth: (in.) Deposits Extent:
Infiltration: **None** Pipe Seal Cond: **Sound**

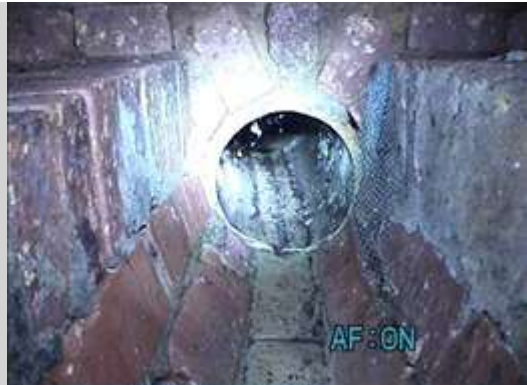
6 O'Clock Inflow

Pipe In @ 6 O'Clock

Invert Depth: **9.80** (ft.) Flow Characteristics: **None**

Connects To: **House connection / Service line**

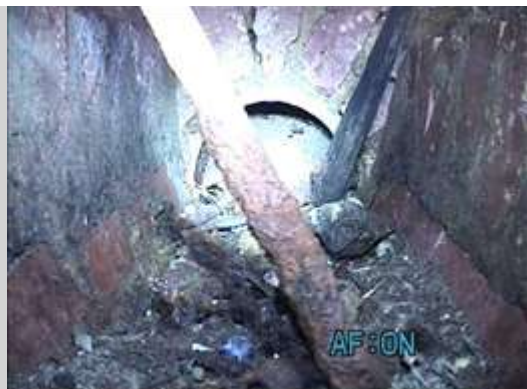
7 O'Clock Inflow

Pipe In @ 7 O'Clock

Deposits: ☐ None ☒ Mud ☒ Sludge ☒ Debris ☐ Grease

Silt Depth: **8** (in.) Deposits Extent: **Heavy**
